# **INDOOR AIR QUALITY ASSESSMENT**

**Belmont Police Department  
460 Concord Road  
Belmont, Massachusetts**

Prepared by:  
Massachusetts Department of Public Health  
Bureau of Environmental Health Assessment  
Emergency Response/Indoor Air Quality Program  
March 2003

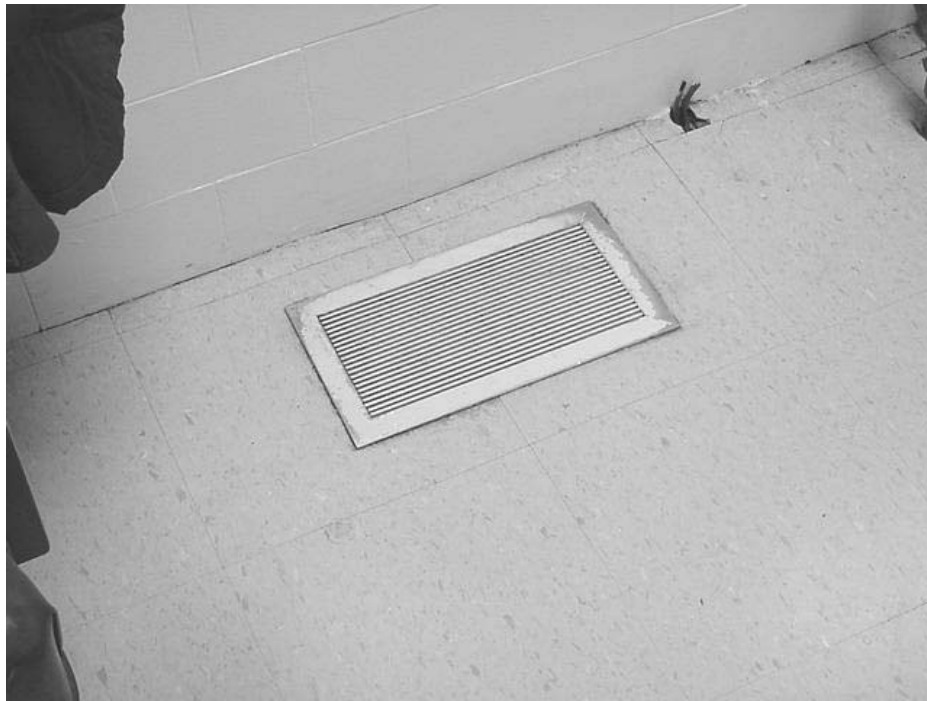
**Picture 1**

**Typical Floor Supply Vent for HVAC System**

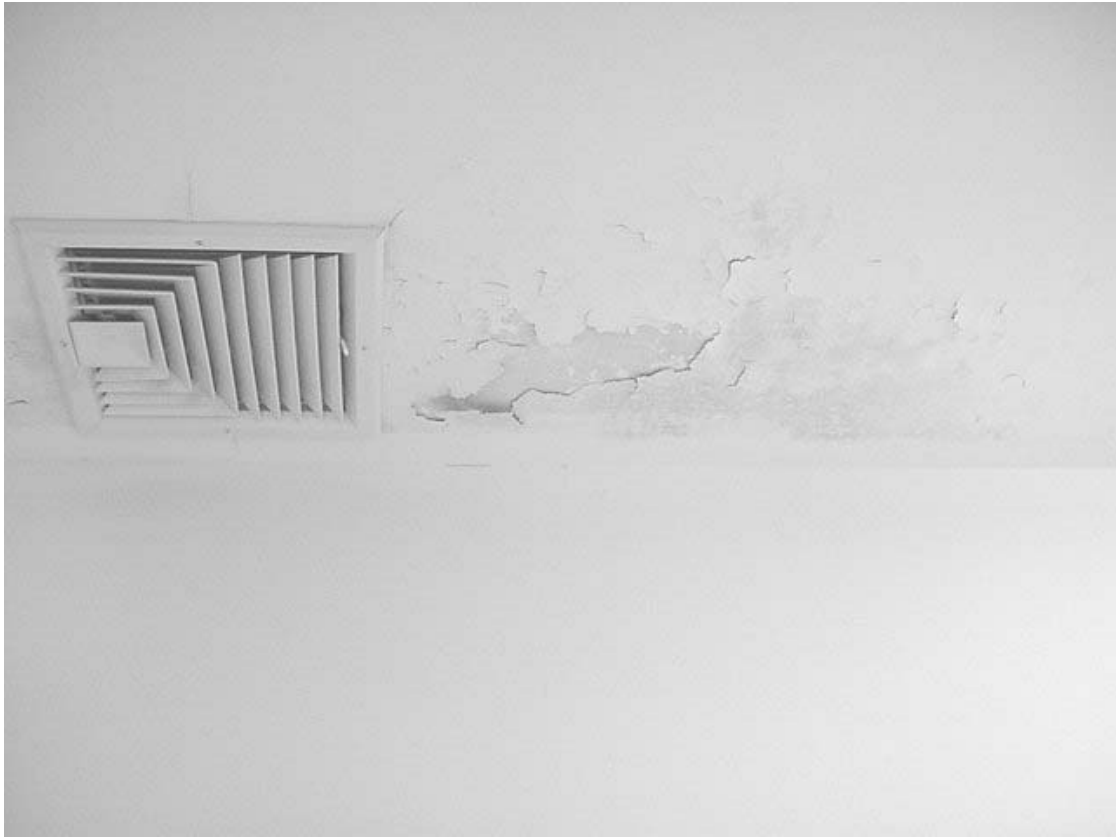
**Picture 2**

Water damaged ceiling tiles and wall/ceiling plaster were observed in several areas of the building (see Tables/Picture 2), which are evidence of roof or plumbing leaks. Water-damaged ceiling tiles, and other porous building materials, can provide a source of microbial growth and should be replaced after a water leak is discovered. Occupants reported an active leak in the men's restroom that occurs during wind-driven rain storms. The American Conference of Governmental Industrial Hygienists (ACGIH) recommends that porous materials be dried with fans and heating within 24 hours of becoming wet (ACGIH, 1989). If these materials are not dried within this time frame, mold growth may occur. Once mold has colonized porous materials, they are difficult to clean and should be removed.

**Typical Ceiling Supply Vent for HVAC System, Note Water Damaged Ceiling Plaster**

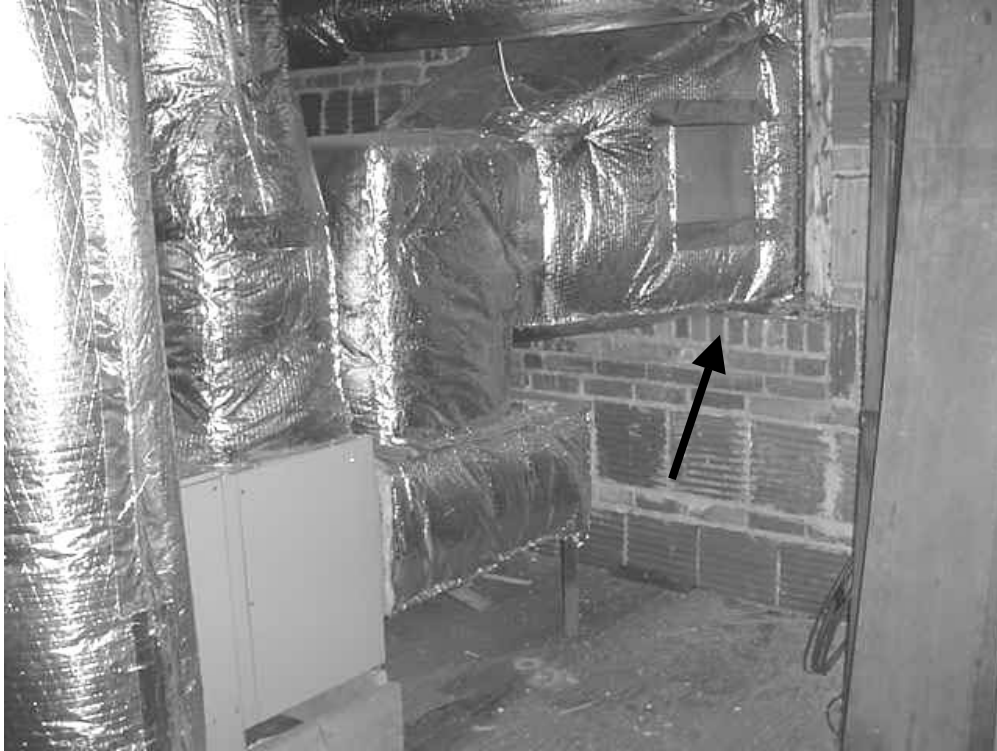
**Picture 3**

It can be seen from the tables that carbon dioxide levels were below 800 parts per million parts of air [ppm] in all areas surveyed, indicating adequate air exchange. An HVAC system provides ventilation through ducted, floor and ceiling vents (see Pictures 1 & 2), connected to three air handling units (AHUs). One AHU is located in the attic. The second is located on the ground floor near the garage. The third is located in a loft in the activity room (see Pictures 3-5). The attic and loft AHUs were connected to outside air intakes. BEHA staff could not identify if the ground floor AHU in Picture 4 was capable of introducing fresh air into the system; since no obvious fresh air intakes for this equipment could be identified.

**AHU Located in Attic, Note Ductwork to Air Intake on Exterior Wall**

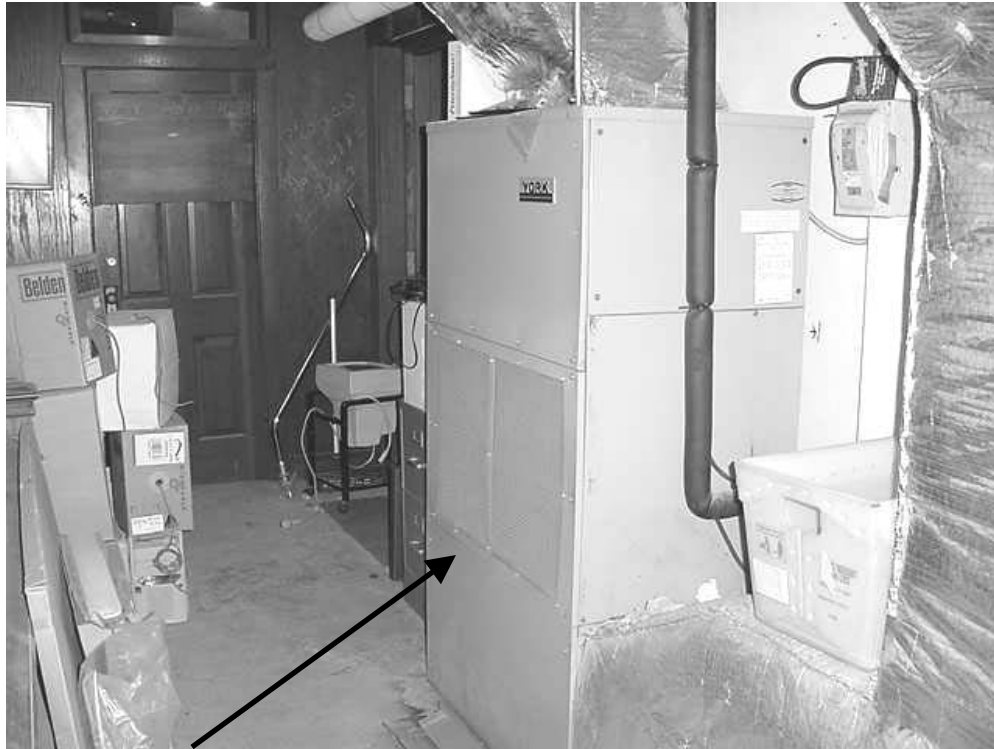
**Picture 4**

**Air Intake/Return Vent**

**AHU on Ground Floor Mezzanine, across from Garage**

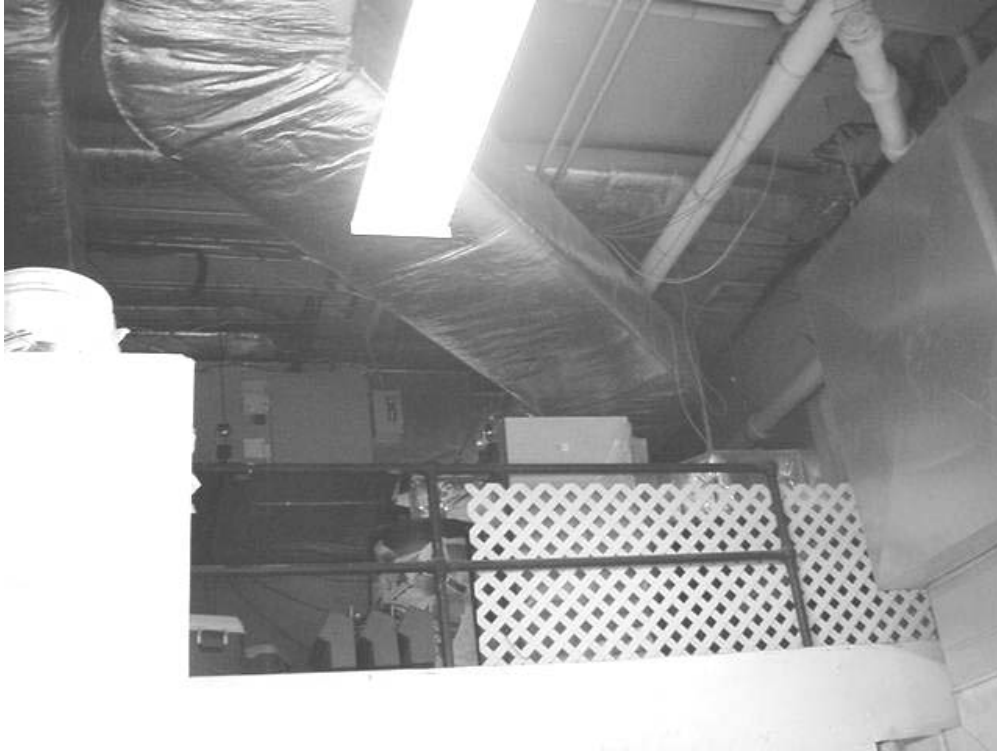
**Picture 5**

**AHU Located in Loft in the Activity Room**

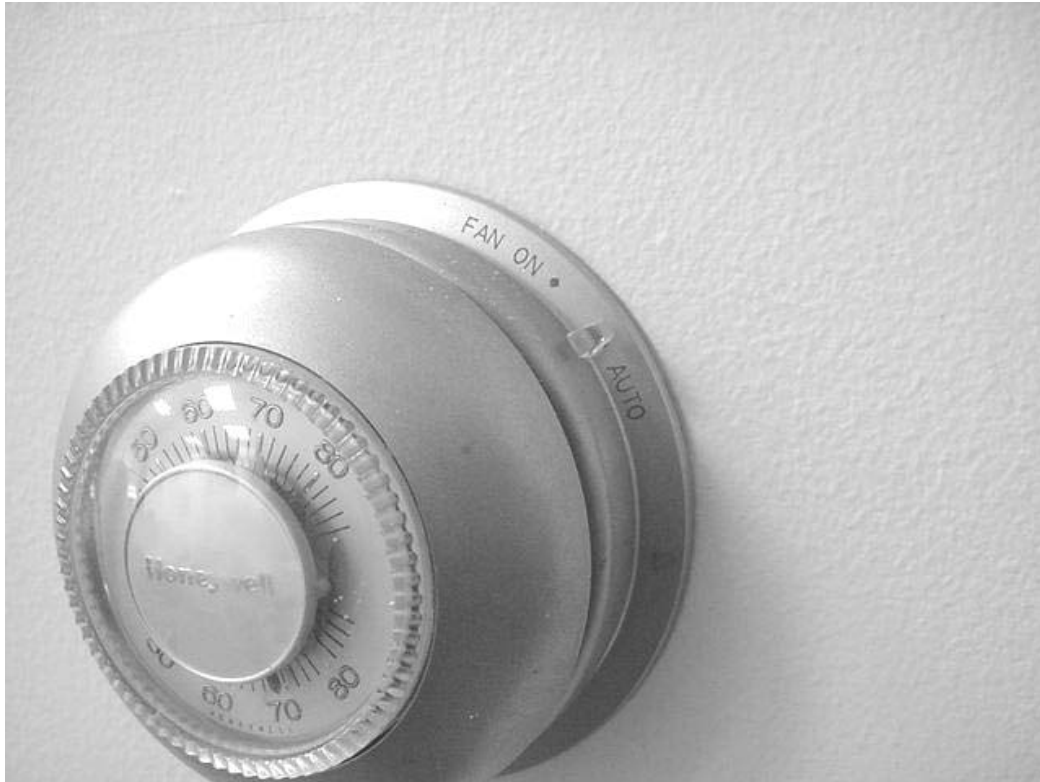
**Picture 6**

The ventilation system is controlled by thermostats (see Picture 6). Thermostats have a fan control, which can be set to either “auto” or “on”. At the time of the assessment, switches were set to “auto”, which deactivates the AHUs once the temperature set on the thermostat is measured. BEHA staff recommended that the fan switch be placed to the “on” position to provide continuous airflow to the space. Without mechanical ventilation running continuously, fresh air cannot be introduced on a consistent basis. In addition, floor vents in the dispatch area were obstructed by equipment, which can impede airflow (Picture 7). Exhaust ventilation in

**Thermostat Set in the Fan “Auto” Setting**

2. Operate HVAC system in the fan “on” setting. To maximize air exchange, the BEHA recommends that mechanical ventilation *operate continuously* during periods of occupancy independent of thermostatic control.

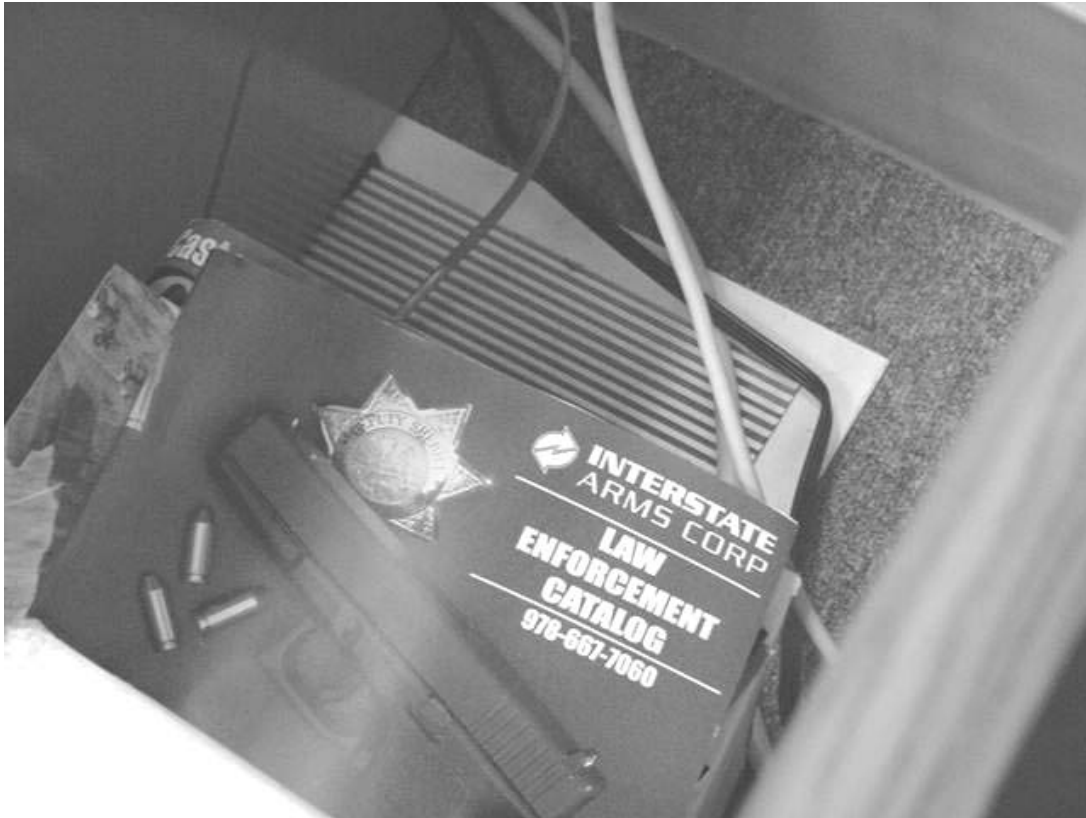
**Picture 7**

**Obstructed Floor Vent in Dispatch/Communications Area**

5. Remove all blockages from air vents to ensure adequate airflow.
6. For buildings in New England, periods of low relative humidity during the winter are often unavoidable. Therefore, scrupulous cleaning practices should be adopted to minimize common indoor air contaminants whose irritant effects can be enhanced when the relative humidity is low. To control for dusts, a high efficiency particulate arrestance (HEPA) filter equipped vacuum cleaner in conjunction with wet wiping of all surfaces is recommended. Avoid the use of feather dusters. Drinking water during the day can help ease some symptoms associated with a dry environment (throat and sinus irritations).

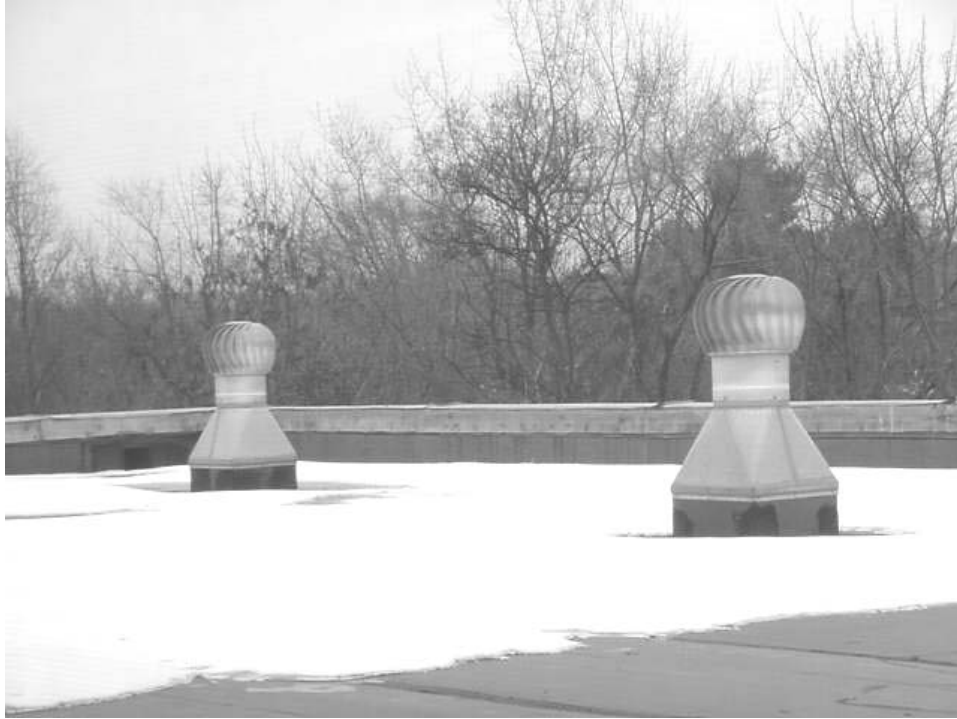
**Picture 8**

The attic is ventilated by wind-driven turbine vents (see Picture 8). As the wind turns the blades of the turbine fan negative pressure is created in the attic space, which pulls out excess heat.

**Wind-Driven Turbine Vents on Roof**

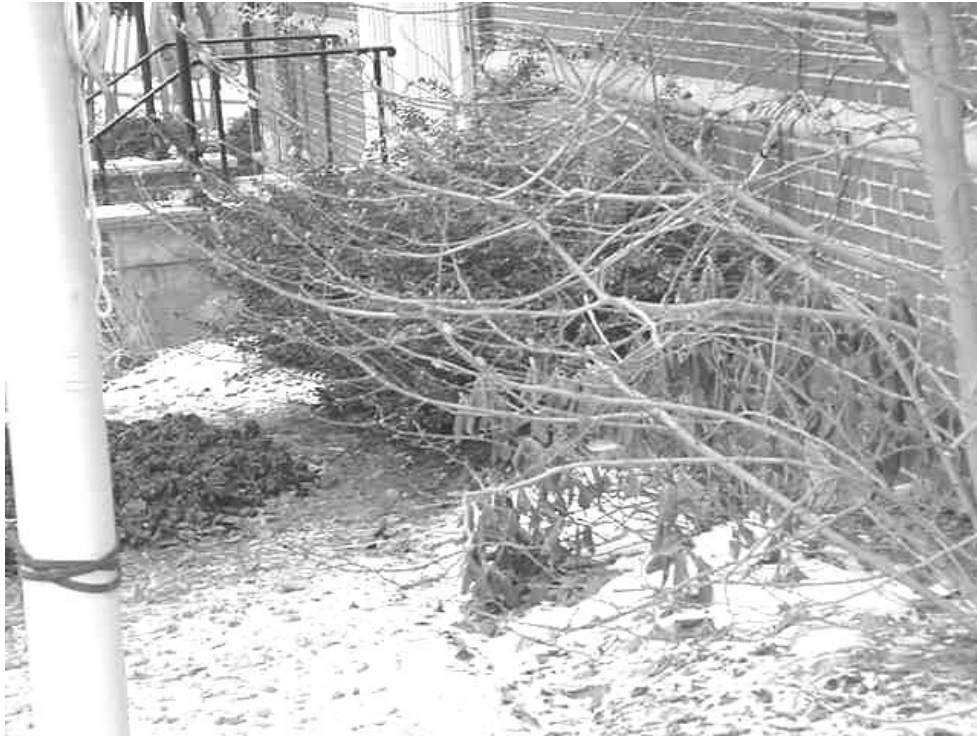
**Picture 9**

In several areas around the building, small trees/stumps and other plants were growing against the foundation and clinging plants were noted on exterior walls (see Pictures 9 & 10). The growth of plants/roots against the exterior walls and along the foundation can bring moisture in contact with wall brick and eventually lead to cracks and/or fissures in the foundation below ground level. Clinging plants can cause water damage to brickwork by inserting tendrils into brick and mortar. Water can penetrate into the brick along the tendrils, which can subsequently freeze and thaw during the winter. This freezing/thawing action can weaken bricks and mortar, resulting in wall damage.

**Plant/Tree Growth Against the Foundation of Building**

7. Remove plant growths against the exterior wall/foundation of the building to prevent water penetration.
8. For buildings in New England, periods of low relative humidity during the winter are often unavoidable. Therefore, scrupulous cleaning practices should be adopted to minimize common indoor air contaminants whose irritant effects can be enhanced when the relative humidity is low. Drinking water during the day

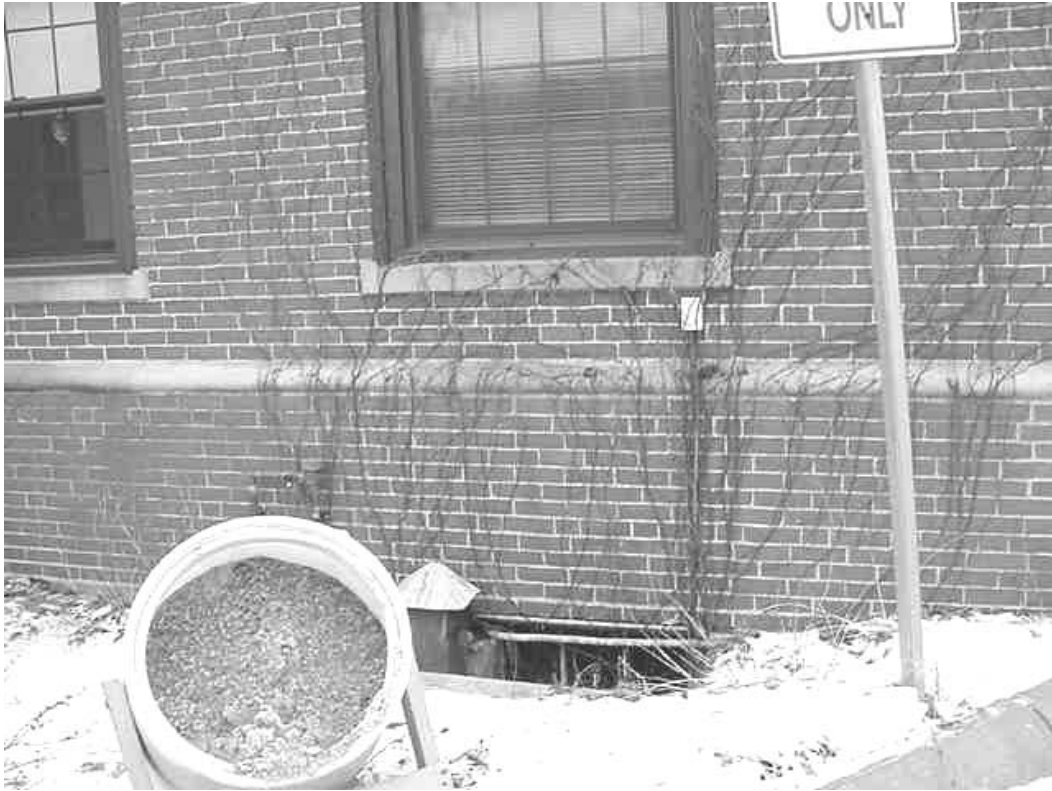
**Picture 10**

**Clinging Plants on Exterior Wall**

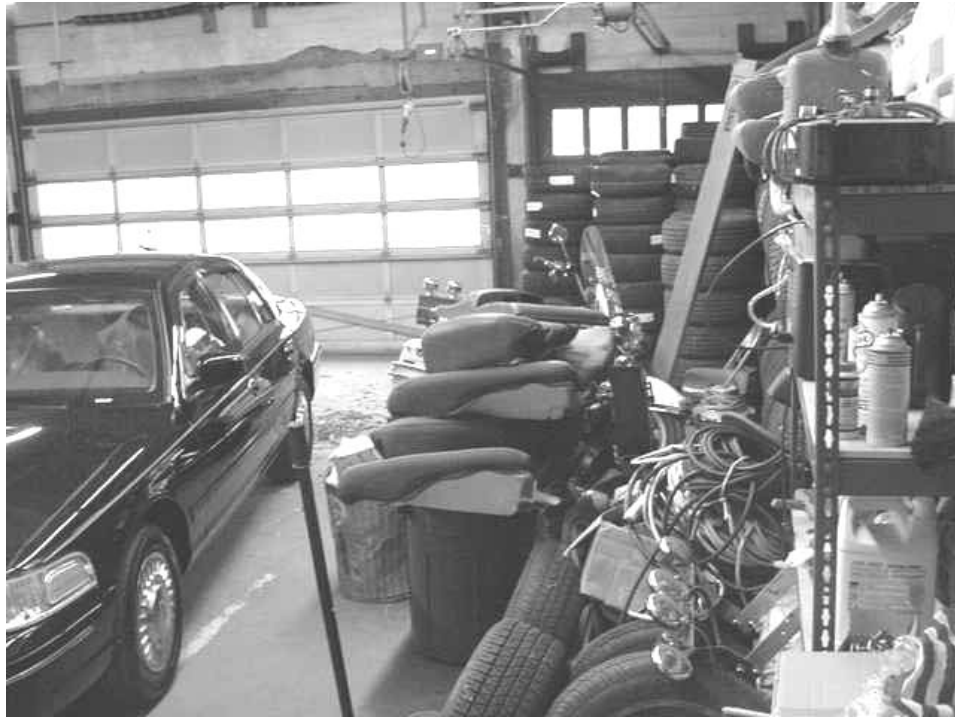
**Picture 11**

other items (see Picture 11). The fuel tank of the motorcycle may provide a source of possible odors due to volatile organic compounds (VOCs) found in gasoline that can off gas and have an adverse effect on indoor air quality. Rubber of new tires can also give off an acrid odor, which can be enhanced by heating. The hallway door to the garage was propped open (see Picture 12). When the garage door is open for vehicle entry/exit, the garage can become pressurized forcing odors from stored items into the ground floor. Also noted was the lack of a door on the boiler room (see Picture 13). Located on the ground floor mezzanine is one of the AHU (see Picture 4), which can draw odors (e.g. fuel, rubber, gasoline odors) into the ventilation system and distribute them throughout the building.

**Interior of Garage, Note Stored Items**

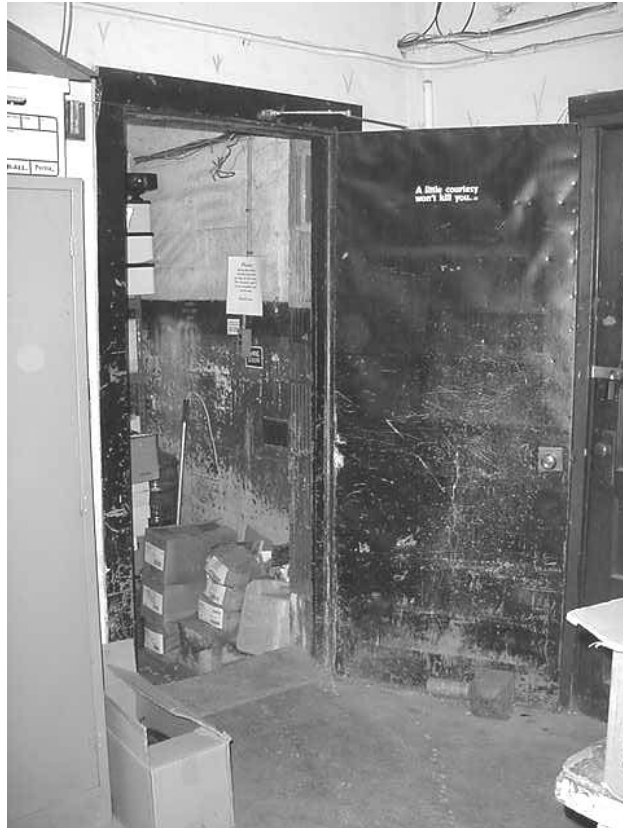
**Picture 12**

**Interior Garage Door Propped Open**

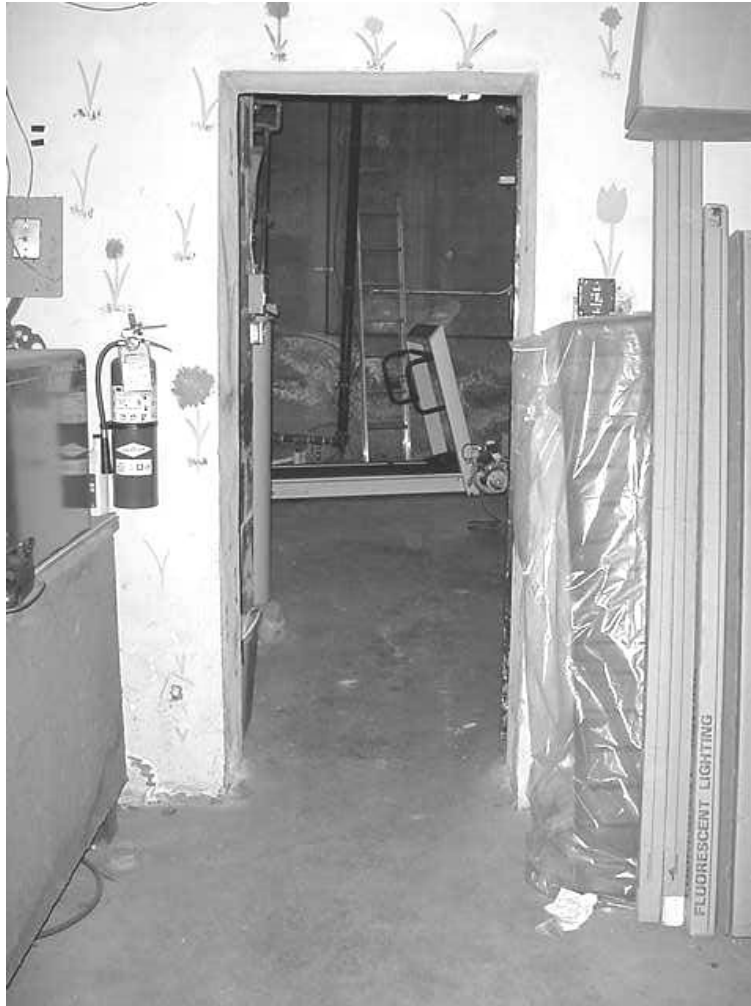
**Picture 13**

**Boiler Room Entrance Without Door**
